AN ANALYSIS OF HOUSEHOLD WATER SUPPLY IMPACTS BY UNDERGROUND COAL MINING IN VIRGINIA

VCCER REPORT NO. 94-2

An Analysis of Household Water Supply Impacts by Underground Coal Mining in Virginia

May, 1994

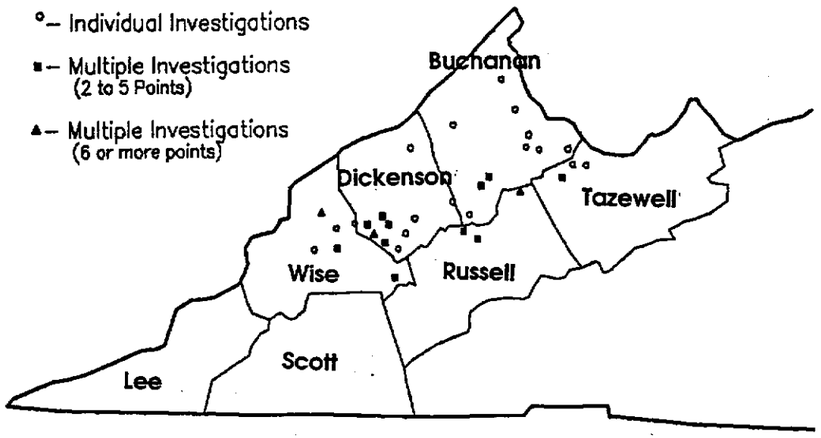
Figure 4. Southwestern Virginia's major coal producing counties, and the locations of VDMLR water loss complaint investigations.

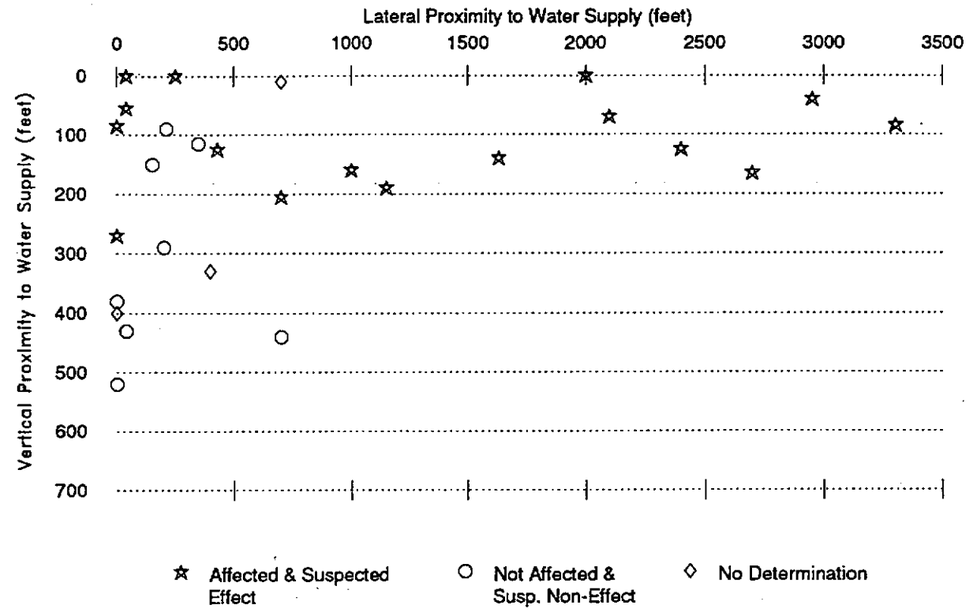
Figure 5. Proximity of water supplies investigated by VDMLR to room-and-pillar mining operations.

Cases 20, 21, and 22 represented water supplies that were either directly above, or in close lateral proximity to, room-and-pillar mines, but with vertical proximities ranging from 380 to 520 feet. Water supply impacts in all three cases were judged by VDMLR to have been caused by dry weather, limited recharge areas, or both.

Cases 17, 18, 19, 23, and 24 were all classified as non-effects, or suspected non-effects. All were drilled wells. In two cases (17 and 18), old mine works were closer to the well bottom than the mining operation which was the subject of the complaints, although no cause-and-effect determination was made with respect to the water loss. In two additional cases (19 and 24), the original water supplies were judged to have been poor to begin with.

In summary, the only water supply falling within the zone of influence specified by Rauch (directly overlying, less than 100 feet) was judged by VDMLR to have been affected by mining. However, this water supply was outside of the primary zone of influence defined by Rauch (i.e. the vertical proximity of the water supply to the mining operation was in excess of 40 feet) and there was a 14 year delay between mining and the water supply effect. Fifteen additional water supplies were classified as affected by, or as suspected effects of, mining. However, in all of these cases, special geologic circumstances were present which were judged by VDMLR

geologists to have contributed to the water loss. In all cases where water supplies were located outside the Rauch-defined zone of influence, and where no special circumstances were noted, the water supply disruptions were determined by VDMLR geologists to have been caused by factors other than mining.

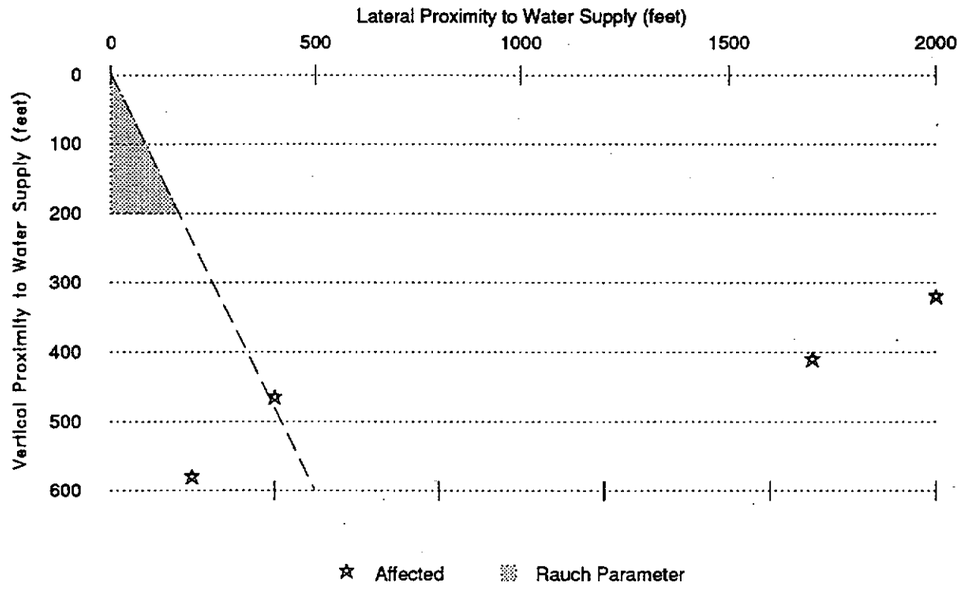
Figure 6. Proximity of water supplies investigated by VDMLR to longwall mining operations.

The VDMLR data set contains only four complaints regarding longwall mines (Figure 6, Table 3); all were the result of the same mine, and all four water supply impacts were judged to have been effects of the mining operation. The panel width was 400 feet. None of the affected water supplies was located within the "critical" dewatering zone described by Rauch. Only one was located within the 20°-to-40°

zone of influence, but above the critical zone (*i.e.*, within the aquiclude zone): Case 31, a hillside spring with vertical proximity of 580 feet, and an 18.5° angle of proximity.

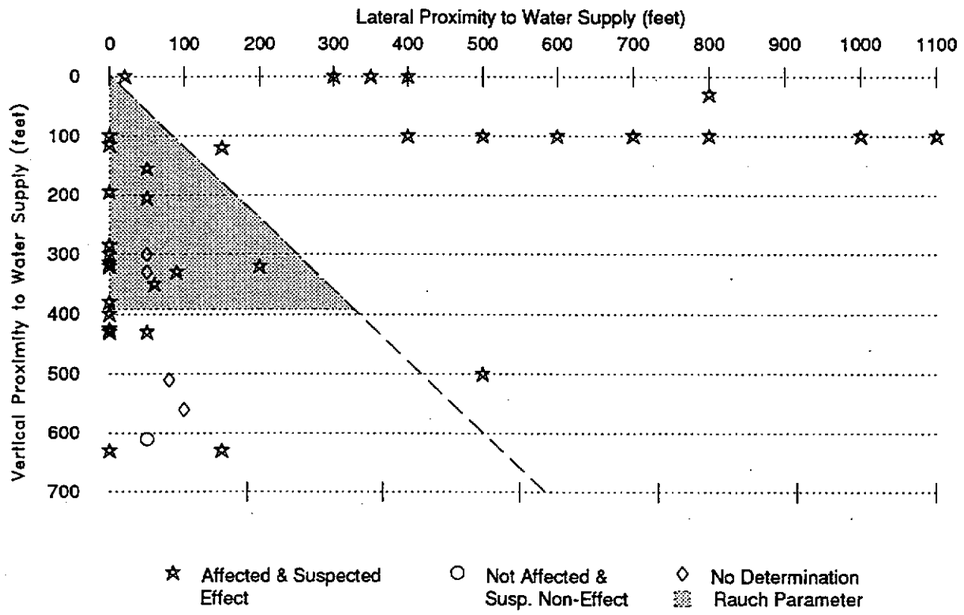
Figure 7. Proximity of water supplies investigated by VDMLR to pillar-retreat mining operations.

Rauch (1989) defines the primary zone of influence for pillar-retreat mining as 120 to 400 feet of vertical proximity, usually within a 20° to 40° angle of draw. Within this zone, according to Rauch, groundwater is affected by rock fracturing and caving caused by subsidence processes. Sixteen of the 41 complaints filed against pillar-retreat mines fell within this influence zone (Table 4, Figure 7). Fourteen of these (including six hillside springs, one spring from an old mine, and seven wells) were determined or suspected to have been affected by mining operations, and no determinations were made with respect to the other two (cases 71 and 72). In case 71, water loss occurred within two months of pillar removal. In case 72, the complaint was filed about one month before pillar removal in apparent anticipation of water loss. No follow-up visit was made to determine whether or not water loss did eventually occur, indicating that the mining company and the complainant settled their differences without further need to involve VDMLR.

Four additional affected (or suspected effect) water supplies were located directly above the mining operations, with vertical proximities in the range of 400 to 430 feet, while a fifth (case 46) was located within this vertical proximity range at a 13° angle

of proximity. Three of these cases (32, 35, and 36) represented hillside springs, while the other two (35 and 46) involved ridgetop wells. In four of these five cases, subsidence features were present. No special circumstances, other than subsidence features, were noted by investigators for any of these cases.

Three additional disrupted water supplies located at vertical proximities greater than 430 feet, were classified as affected or suspected effects. Two were located at angles of proximity less than 40°, while the third (case 34) was located at 45°. Cases 34, 47, and 48, were all hillside springs located 500 feet to 630 feet above the mining operation. In cases 47 and 48, subsidence features were present; in cases 34 and 47, water losses occurred shortly after the pillars were pulled. No special circumstances, other than subsidence effects, were noted by investigators for any of these cases.

Case 43 represents an affected well whose base was relatively close to the mining operation (vertical proximity of 150 feet; lateral proximity of 120 feet) and where no special circumstances were noted by investigators. The well went dry within one week after pillar removal, and subsidence features were present. These factors suggest that this water-supply impact may have been the result of rock-fracturing subsidence processes which define the primary zone of subsidence influence, although this well was located at a 52° angle of proximity.

The one non-affected pillar-retreat case (66) was a ridgetop well whose base was 610 feet above the coal seam being mined, with a 50 foot lateral proximity (*i.e.*, an angle of proximity of 4.5°). The causes of water supply disruption were determined to be limited recharge area and extremely dry conditions. In this case, however, two abandoned room-and-pillar mines were located between the mining operation that was the subject of the complaint and the disrupted water supply, at vertical proximities of 355 feet and 410 feet.

Thirteen additional cases were judged by VDMLR investigators to have been affected by (or were suspected to be effects of) mining, where special circumstances were noted. Cases 33, 40, 67, and 68 represented situations where the well tapped a coal-seam aquifer up-dip of a mining operation, and the mining operations drained the aquifer. Eight cases (51 through 56, 61 and 62) were the result of a single mine operating along the axis of a syncline, with the water supplies being located along the flanks of that syncline. Apparently, the mine drained water from the syncline, thus draining these eight wells. All eight wells were at relatively shallow depths (100 feet or less), indicating that they were tapping the weathered surface zone identified by Harlow and LeCain (1993) as an aquifer unit. Case 59 was associated with a mine which required extensive pumping. Although lateral proximity of the well bottom to the mine was 800 feet, vertical proximity was only 30 feet and VDMLR investigators judged the disruption to be an effect of mining; they also stated that they expected water levels to return to normal once pumping ceased.

To summarize the VDMLR investigations of pillar-retreat mining: Of the sixteen cases which fell within the primary influence zone defined by Rauch, water losses occurred in fifteen cases; fourteen of those cases were judged by VDMLR investigators to have been effects, or suspected effects, of mining and no determination was made with respect to the fifteenth. Nine additional cases of mining-affected (or suspected-effect) water supplies, where no special circumstances other than subsidence effects were noted, fell just outside of Rauch's zone of influence. Vertical proximity in six of these cases was 430 feet, or less; the other three were 500 to 630 feet above the mined coal seam. Only two of these nine cases were located at an angle of proximity beyond 40°: Case 43, a drilled well located at a 52° proximity; and case 34, a spring located at 45°. Six of the nine cases (including all three whose vertical proximities exceeded 450 feet) involved hillside springs. Special circumstances were identified as being responsible for all other 13 mining-affected (or suspected-effect) water supplies, including a major fracture zone and drainage of coal-seam aquifers by mining operations.
